SDG&E Response To Ed Clark's Claims January 11, 2008

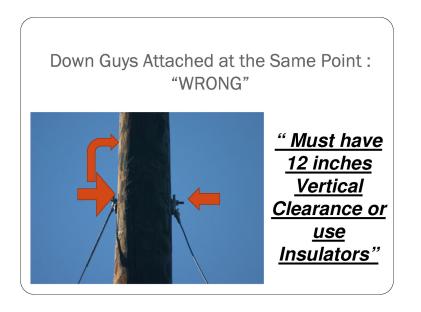
SDG&E Response #3

Also, the 1-ft separation rule does not apply for anchors which act in "different directions", GO-95 Section 56.4, D, 3, b (3). The picture from Mr. Clark's presentation clearly shows anchor guys coming from the pole in different directions.

This California state rule cited by Mr. Clark doesn't apply to anchor guys acting in opposite directions.

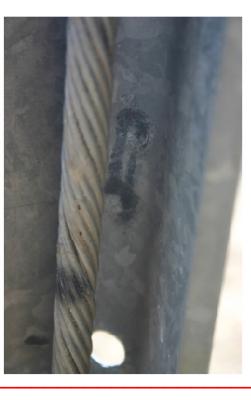
Mr. Clark's Presentation Slide #14

More Arcing

SDGE Response #5

The black spot on the wire in Mr. Clark's picture is actually an old paint band applied by the manufacturer to the "Preform Type Guy Grip" to designate the size. Black means that it fits

<u>5/16-inch galvanized guy wire.</u>

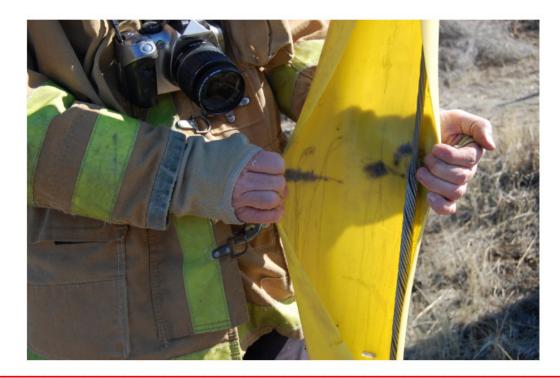
Mr. Clark's Presentation Slide #18

Carbon resulting from Arcing

SDG&E Response #6

<u>Arcing occurs between two metallic objects.</u>

Mr. Clark seems to suggest that the guy wire was somehow arcing to the plastic (non-metallic) guy guard.

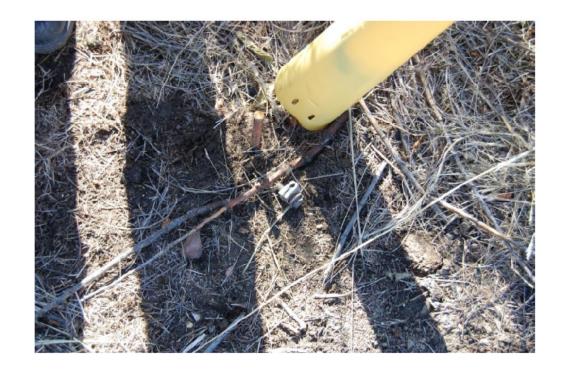
Mr. Clark's Presentation Slide #19

Ground rods found at various locations??

SDG&E Response #7

Since the early 1980s, the SDG&E transmission standard has been to install anchors that have a protective coating which inhibits corrosion. Down guys attached to a coated anchor rod are "securely grounded." A ground rod is driven next to the anchor to accomplish this task.
